# Sun Fire™ B1600 Chassis and B100s, B100x, and B200x Blade Product Notes

Part No. 817-5626-12  
May 2004, Revision A

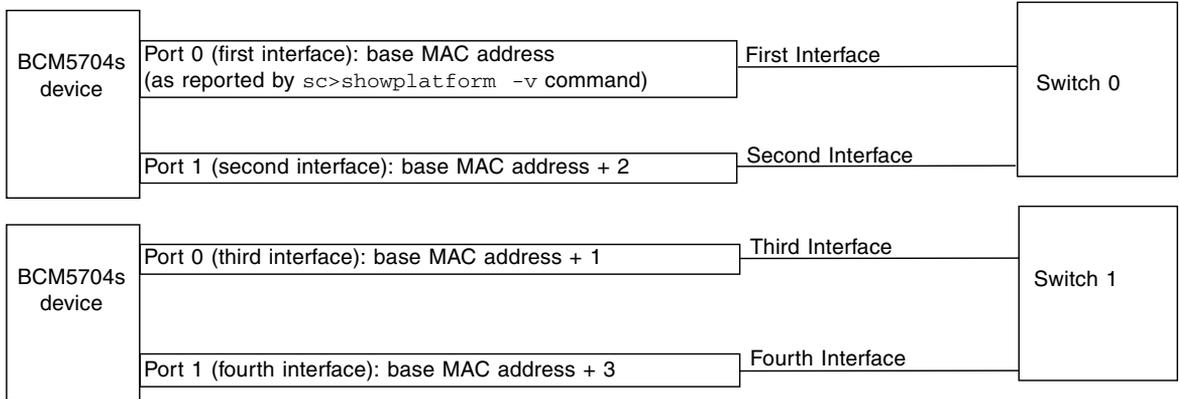
**FIGURE 3-1** The Network Interfaces on a B200x Blade

The B200x blade has two dual-port BCM5704s Gigabit Ethernet chips. Each individual port is connected to one of the Ethernet switches in the B1600 chassis, and the BIOS takes responsibility for assigning the MAC addresses to the Ethernet ports (see FIGURE 3-1).

From [FIGURE 3-1](#) and [FIGURE 3-4](#) you can see that the bge0 and bge1 interfaces have even MAC addresses and are connected to Switch 0 (SSC0), and that the bge2 and bge3 interfaces have odd MAC addresses and are connected to Switch 1 (SSC1).
